DELaware RIVER BASIN
MILL DAM
COMMONWEALTH OF PENNSYLVANIA
WERNERSVILLE STATE HOSPITAL

NDI NO. PA-00711
DER NO. 6-295
BERKS COUNTY, PENNSYLVANIA

PHASE I INSPECTION REPORT
NATIONAL DAM INSPECTION PROGRAM

PHASE I REPORT
NATIONAL DAM INSPECTION PROGRAM
BRIEF ASSESSMENT OF GENERAL CONDITIONS
AND RECOMMENDATIONS

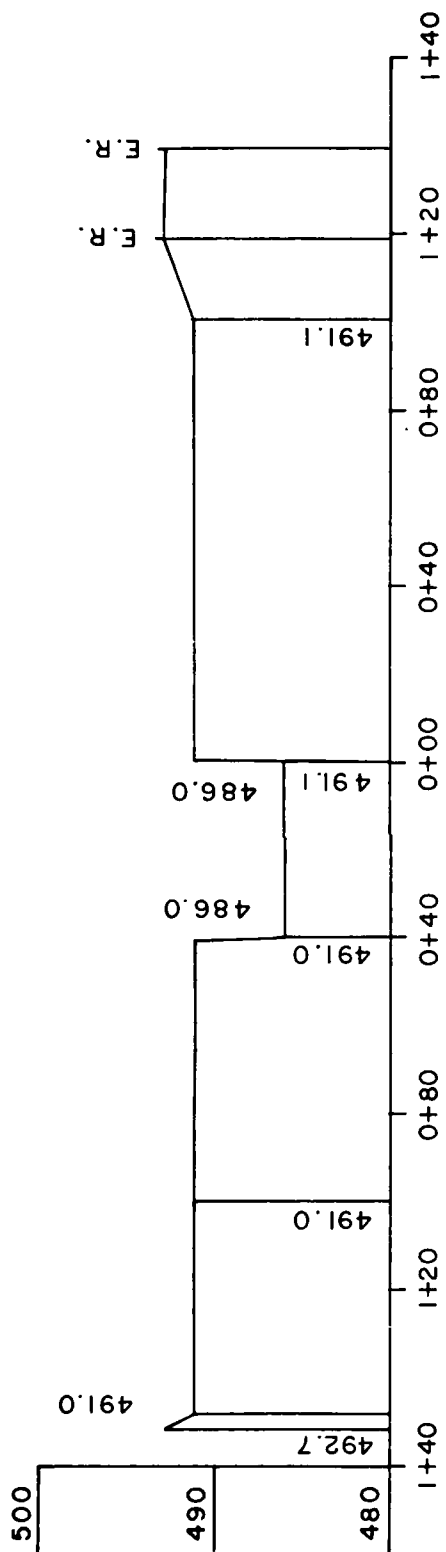
EMBANKMENT PROFILE LOOKING DOWNSTREAM

The downstream face has some wet spots close to the downstream toe. No major seepage was noticed, and no cracks from frost damage were detected. The wet condition is not considered to be serious at the present time.
